Safety Corner

“Ah the Good Old Days!” – Prelude by Dave McClurkin

B-36B, 44-92035, November 22, 1950

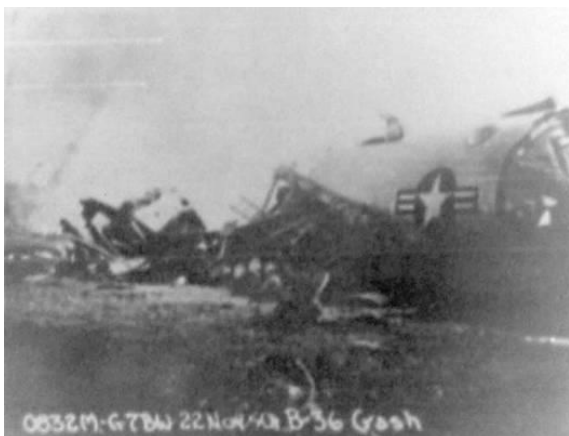
The B-36B descended straight ahead in a nose-high attitude for a mile after Aircraft Commander Hildebrandt bailed out. It stalled, pitched nose down, and impacted in a terraced field on Less Armstrong's Dairy, 14 miles south of Carswell Air Force Base, two miles west of the South leg FTW range, and six miles west of Crowley at 9:50 in the morning. The forward crew compartment separated and folded underneath the rest of the fuselage. The tail section broke off, and the rear crew compartment came away from the mid-fuselage as the wreckage slid 850 feet along the ground and twisted to the right.

The rear sections of the airplane remained largely intact. The elevation at the crash site was approximately 700 feet. Mr. W. Doggett witnessed the bail-out and crash from his home on Route 1 near Joshua. The B-36B impacted about two miles north of his house. He drove to the crash site in his pickup truck and helped the surviving crew members to regroup.
