Safety Corner

“Ah the Good Old Days!” – Prelude by Dave McClurkin

B-36B, 44-92035, November 22, 1950

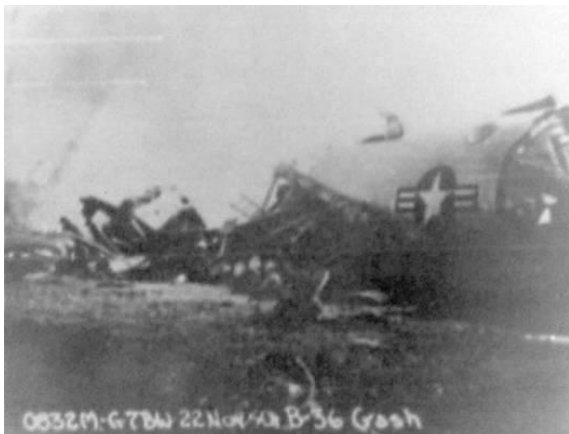
The B-36B descended straight ahead in a nose-high attitude for a mile after Aircraft Commander Hildebrandt bailed out. It stalled, pitched nose down, and impacted in a terraced field on Less Armstrong's Dairy, 14 miles south of Carswell Air Force Base, two miles west of the South leg FTW range, and six miles west of Crowley at 9:50 in the morning. The forward crew compartment separated and folded underneath the rest of the fuselage. The tail section broke off, and the rear crew compartment came away from the mid-fuselage as the wreckage slid 850 feet along the ground and twisted to the right.

The rear sections of the airplane remained largely intact. The elevation at the crash site was approximately 700 feet. Mr. W. Doggett witnessed the bail-out and crash from his home on Route 1 near Joshua. The B-36B impacted about two miles north of his house. He drove to the crash site in his pickup truck and helped the surviving crew members to regroup.

Four minutes after the crash, McCullough and Boeten in DC-3, N342 reported that two Navy aircraft were circling the wreckage. The wreckage smoldered for about eight minutes before a fire broke out in the number-six engine. The 15,000 gallons of remaining fuel consumed the forward fuselage and wings. The civilians and crew members were driven away from the crash site by exploding ammunition and the knowledge of the presence of 500 pounds of bombs aboard the airplane.
