Safety Corner

“Ah the Good Old Days!” – Prelude by Dave McClurkin

B-36B, 44-92035, November 22, 1950

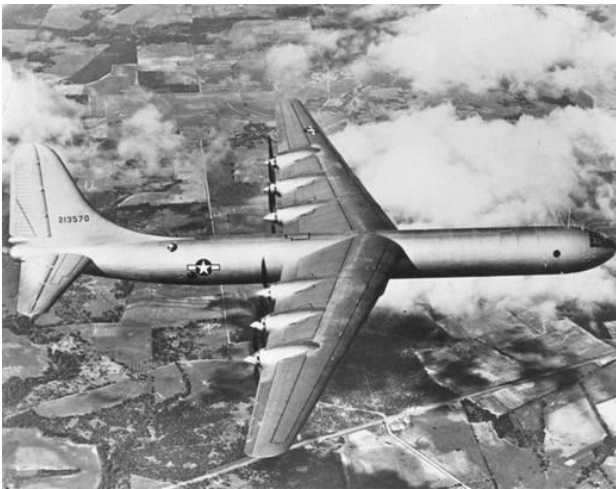
Immediately after take-off, the #4 alternator would not stay in parallel with the other three alternators, so it was taken off-line and de-excited three minutes into the flight. About one minute after the #4 alternator was shut down, flames 8 to 12 feet long erupted from around the air plug of the number-one engine. The left scanner reported the flames to the pilot. Six

minutes after take-off, the flight engineer shut down the number-one engine, feathered its propeller and expended one of its Methyl bromide fire extinguishing bottles.

At 7:31 a.m. the number-three engine suffered an internal failure. The torque pressure fell to zero. The manifold pressure dropped to atmospheric pressure. The fuel flow dropped off, and the flight engineer could not stabilize the engine speed. The pilot shut down the number-three engine and feathered its propeller. The B-36B had only one operating engine on the left wing, so the pilot aborted the remainder of the training mission and set course for Kelly Air Force Base.

After a short while the number-five engine lost power, and Aircraft Commander Hildebrandt feathered the propeller on that engine while still twenty-one miles from Carswell Air Force Base. The B-36B could not stay airborne on the power of the three remaining failing engines. It was flying at just 125 miles per hour, seven miles per hour above the stall speed, losing both altitude and airspeed. Howard McCullough and W. Boeten were flying Civil Aeronautics Authority DC-3 N342 near Cleburne. They were notified by Meacham Tower to be on the lookout for 44-92035. They spotted it about five miles south of Cleburne. They observed that the number-one and number-three propellers were feathered and the number-five engine was on fire. They turned to follow the descending bomber. Aircraft Commander Hildebrandt ordered the crew to bail out of the stricken bomber.
